TransTechnical ***Bulletin***

Application: E40D/4R100 1989-UP
Subject: Center Support Gasket

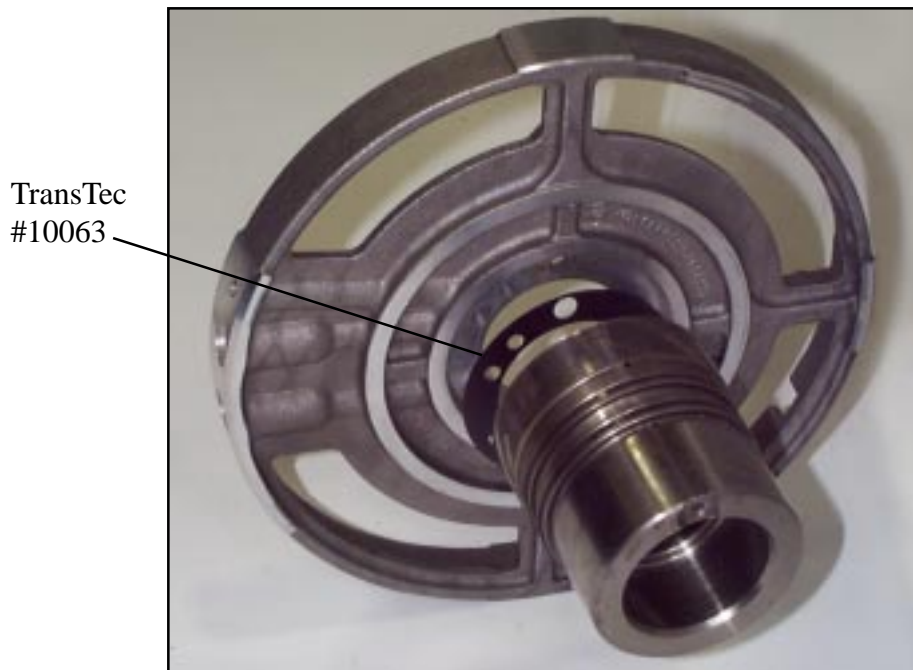
To improve sealing between the center support and the center support hub, TransTec has developed a rubber coated metal gasket. This gasket was designed with the bonded material so that there is no chance of gasket blowout at the feed holes.

CAUTION: Mating surfaces of both the center support and center support hub must be smooth and flat to insure proper sealing. Wrong installation of gasket can block the forward clutch oil feed hole. Care must be taken when installing the gasket so that the forward clutch oil feed hole isn't blocked.

It is recommended that a thread locker compound be used on the mounting bolts and then progressively torque to 100-120 in.-lbs. in three steps.

All TransTec E40D/4R100 kits with a date code of D01 and later will have the new gasket under TransTec #10063.
